PRE-CAST CONCRETE FIREPLACE DAMAGE AND REPAIR

Written by Dale W. Feb

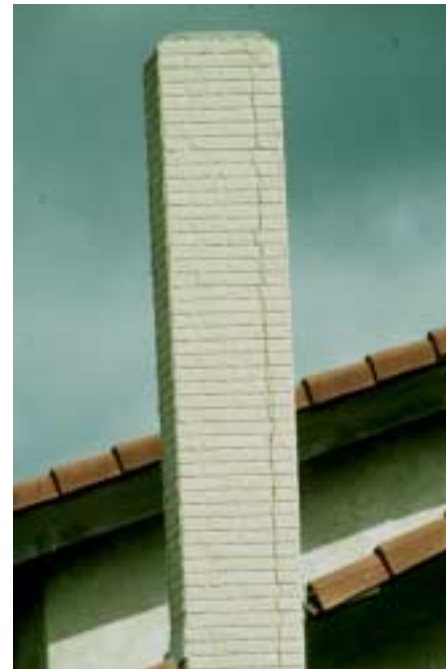
Although there are surface cracks in most concrete structures, the cracks of concern in the Pre-Cast Concrete Fireplace are addressed within the manufacturer's repair specifications. Cracks that do not pass through the walls into the interior areas may be repaired. However you must repair as per the manufacture's specifications. If the cracks are not repaired as per these specifications they have a higher tendency to return. These cracks are required to be cut out a minimum 1/2" wide by 2" in depth. Then a non-shrink grout with a minimum 2000 pound compression rating must be applied to replace the removed material. This repair method has proven to perform fairly well. The cracks found on the exterior of the fireplace structure are often caused by either the calcium chloride additive or seismic activity. The calcium chloride additive was placed in the concrete to speed up the curing time. The cracks caused by this calcium chloride usually follow the location of the vertical and horizontal steel reinforcement. When the calcium chloride is mixed with moisture a reaction occurs and rust scale develops on the steel reinforcement. This reaction and expansion of the steel reinforcement causes fractures in the concrete. These cracks always start on the exterior surface first.

Remember moisture is required to activate this process. A good coat of paint may help reduce moisture entry but does not eliminate this deterioration.

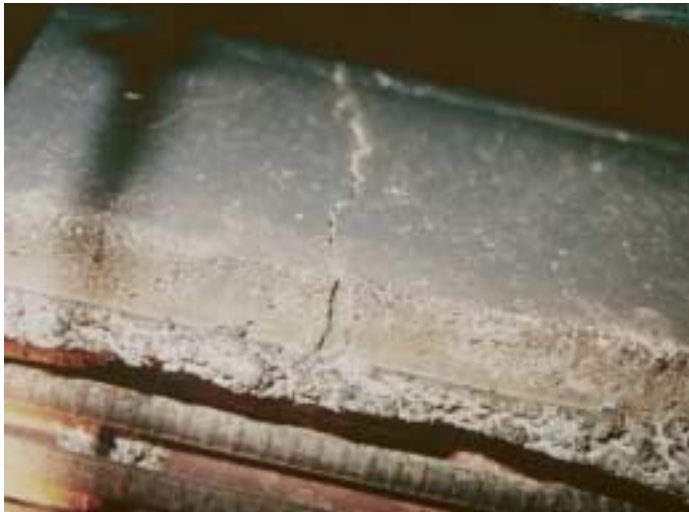
There are several weak points on this pre-cast concrete fireplace that are susceptible to a seismic event. The chimney, transition, walls of fireplace, as well as the insulation plate. The chimney has a tendency to crack horizontally at several locations. The transition is where the exterior shoulders of the fireplace meet the chimney. This is a common location for a crack due to the movement of the upper chimney. A horizontal crack within the interior flue can be found approximately six inches above the base of the flue liner. This crack correlates with the exterior damage found at the transition. The sides and rear of the fireplace are also very common points of failure. You may find one to three horizontal cracks per side on the fireplace. The rear wall of the fireplace may have both vertical as well as horizontal cracks. In many cases the horizontal cracks at the rear wall will meet up with the horizontal cracks at the side walls. Also note that the cracks on the interior firebox may be slightly different than the exterior cracks. This is due to the calcium aluminate firebox liner and the lightweight structural concrete being laminated together at the time of assembly. Remember that the manufacture states, "Cracks or punctures extending completely through a wall of the firebox area, throat area or chimney section **are not** subject to patching". Full removal and replacement of the fireplace may be required at this time. The true concern is that the cracks may allow the passage of heated gases into the combustible wall and create a fire hazard.

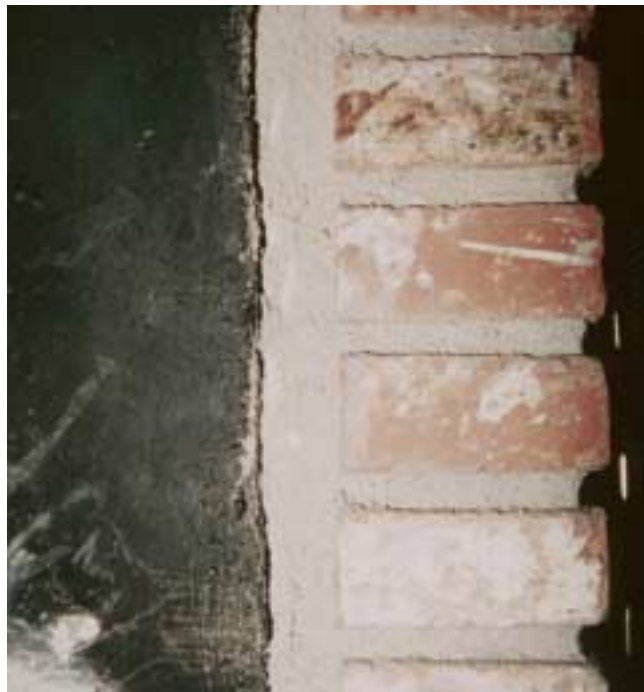
There is one additional location of concern that should be considered a high fire hazard. In many cases with the pre-cast concrete fireplaces there is a separation or gap between the face of the firebox and the decorative detail applied around the fireplace opening. This gap or crack located just inside the fireplace opening poses a real fire hazard. This separation could be due to seismic activity or simply the failure to close this area at the time of the veneer installation. In both cases this opening may cause a secondary chimney that will actually draw the heated gases into the wood framed wall. In time this exposure may cause ignition based on time of exposure, temperatures of the heated gases and the materials being exposed. This condition is easily corrected with the use of an approved material to block the passage of the heat.
