PRE-CAST CONCRETE FIREPLACE DAMAGE AND REPAIR

Written by Dale W. Feb

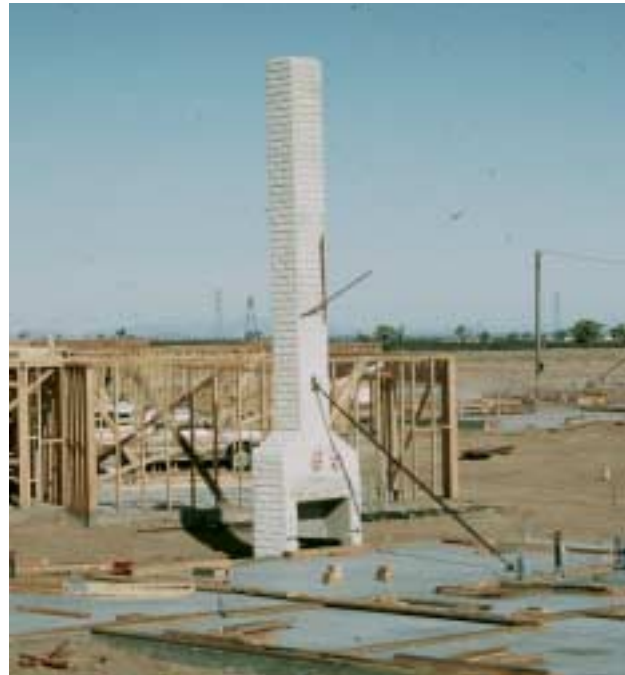
the footings were post-tension. Please be aware that the post-tension cables found within this concrete footing should **never** be cut during the removal of a damaged pre-cast concrete fireplace. Injuries may occur and the repair cost is substantial. Once the footing had cured, the brace was removed and the wood framed dwelling was constructed.

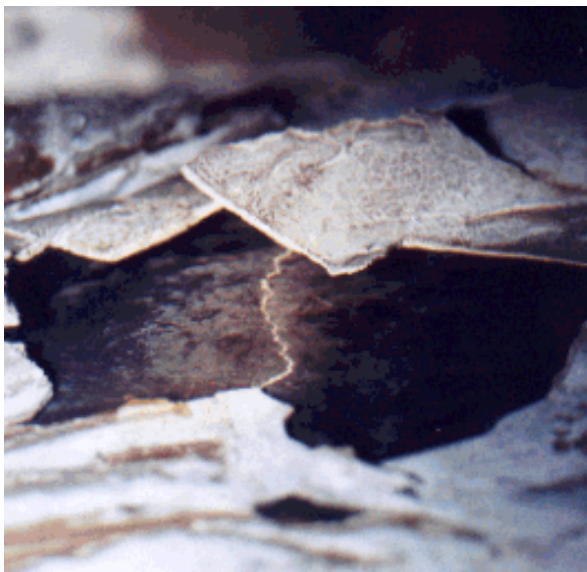
This means that if we decide to change or alter the existing pre-cast concrete fireplace outside the perimeters of the manufacturers' specifications then we invalidate the approval program required for the safe installation and operation of these fireplaces. The **incorrect type of repairs** that would fall into this category would be the replacement of the concrete chimney with a Class "A" chimney pipe, relining of the existing flue, the repair to a fractured "insulation plate" or the improper repair to exterior surface cracks. All of these incorrect repairs ultimately change the original structure, change the design or provide an unproven and/or potentially dangerous condition. Therefore any
